# PLAUSTRA

## WSR Bi-Monthly Newsletter of the Wagon Restoration Group

## Progress – Brake Van

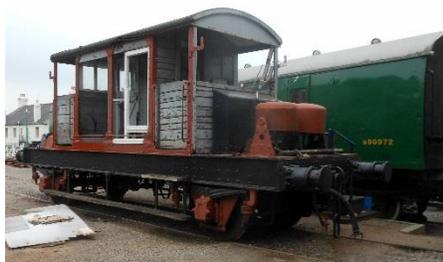
We must give a big thank you to Andy Hurly and his staff who have made the sub frames for supporting the duckets seen painted white in photos.

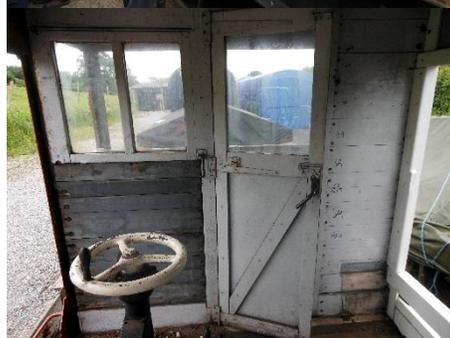
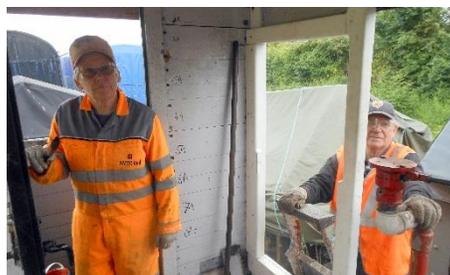
The above 2 photos show the most obvious moisture trap on the brake. There are drainage holes but since 1942 they have slowly filled until they blocked and water rotted away the timber base plates. The timber is on order and Mike will make new ones for fitting soon.
